Nessfield Accessibility Action Plan

4.1 Action Table				
COSTS – N = NONE M= MINIMAL OG = ONGOING MAINTENANCE ST = STRUCTURAL CHANGE EX = MAJOR STRUCTUARL CHANGE				
Item Ref.	Details/Issue	Recommendation	Est Cost	Action Taken
PRIORITY A

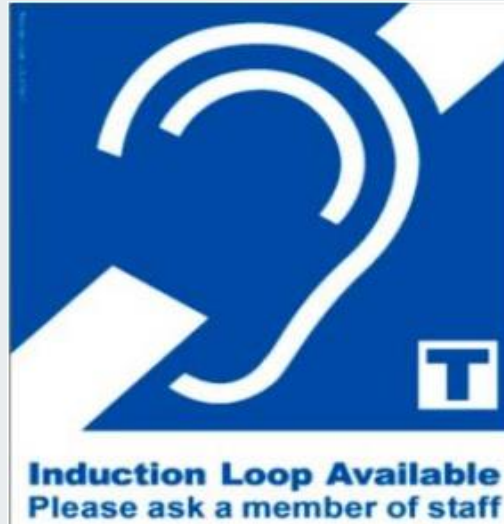
6.5

There is no induction loop provided to the reception desk to accommodate hearing aid users who struggle when there is background noise.

Install an induction loop to the reception desk. Install signage indicating the availability of the facility and ensure that staff members are aware of how to use the system. ADM vol-2 requires that any reception point is provided with a hearing enhancement system, e.g. an induction loop and the presence of an induction loop or infrared hearing enhancement system is indicated by the standard symbol:

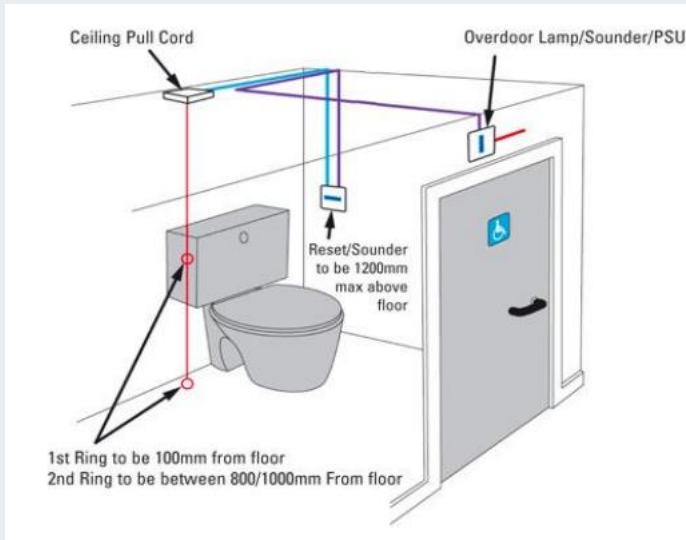
<p>13.10</p>	<p>On the day of the survey, the sanitary bins or other items were stored within the transfer area of the accessible WC denying wheelchair users the appropriate transferring techniques in which an accessible WC is designed to provide.</p>	<p>Accessible WCs must be regularly inspected in order to maintain the transfer zone alongside the WC free of obstructions. Bins and other items can prevent wheelchair users from approaching and transferring. It is vitally important and is strongly recommended that a management procedure be implemented to ensure that accessible WC facilities are always kept clear. This will enable wheelchair users to adopt the many transfer techniques available to them in which an accessible WC is designed to provide. Without a free transfer area, a wheelchair user is highly unlikely to be able to use a facility.</p>		
<p>13.11</p>	<p>Accessible WC 66 has a cord alarm but the day of the survey, the cord alarm within the accessible WC was not hanging loose, being obstructed by the bin hence should someone stumble on the floor they would not be able to reach it.</p> <p>The Accessible WC with shower and hoist in Room 39 has no emergency cord alarm provided.</p>	<p>Cord alarms should be provided, and monitored to ensure that they function correctly and are located at full length in their correct position so that they can be accessed in the event of an emergency.</p> <p>Emergency alarm cords should always feature bangles at two heights and stand at 100mm off the ground floor level. According to BS8300 an emergency assistance pull cord should be sited so that it can be operated from the WC and from an adjacent floor area. The emergency assistance pull cord, coloured red, should be provided with two red bangles of 50 mm diameter, one set at a height between 800 mm and 1000 mm and the other set at 100 mm above floor level.</p> <p>BS8300 recommends that the reset control for the emergency assistance alarm should be clearly marked as such and should be reachable from a wheelchair and, where relevant, from the WC. The reset control should be easy to operate and located with its bottom edge between 800 mm and 1 000 mm above finished floor level. The marking of the reset control should be both visual and tactile.</p>	<p>N/M</p>

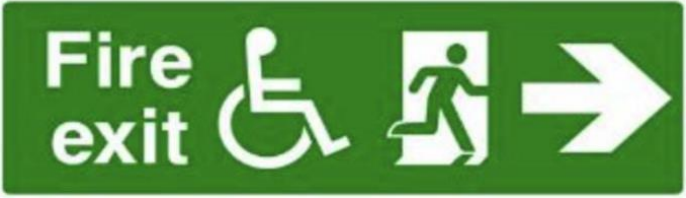
<p>17.2</p>	<p>Level egress is available out of the all the fire exits but some areas will require use of steps to get away from the site.</p> <p>There are steps on one of the exit from area 61 that leads past the hall but the adjoining exit provides level access to the school playground and ramped routes to the Nessfield Drive.</p>	<p>Ideally permanently ramped exits should be provided.</p> <p>However, where this is not possible, it is acceptable in the short-term to provide suitable evacuation equipment where appropriate and ensure that any accessible exit route is suitably signed to direct people to a level egress point.</p> <p>Any equipment and assistance must be part of an escape plan, see recommendations 18.5, 18.6, 18.7</p>

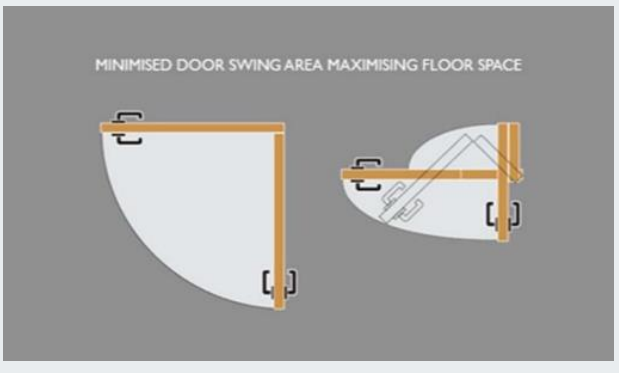
13.3

The Accessible WC with shower and hoist in room 39 has an inward opening door. It is used as first aid room. Kept locked - key locker, located high.

BS8300 recommends outward opening doors in regard to sanitary accommodation. However, the use of reduced-swing door sets, which have a sliding/folding action, reduces the door swing into the room and corridor and supports manoeuvring in and out of toilets and bathrooms.

Any door to sanitary accommodation, whether opening inwards or outwards, should be capable of being opened in an emergency if a person inside has fallen against it and is unable to move. The use of pivot hinges, in conjunction with an emergency release door stop and bathroom lock openable from the outside, can provide this facility.

If required, would be recommend to consider the option of the use of a Pivette door such as seen here:

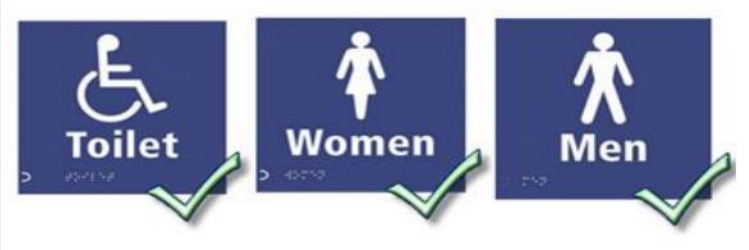
<p>15.3</p>	<p>There is a lack of signage to indicate where the toilets are located, there is no tactile or Braille signage provided on the toilet doors.</p> <p>The accessible WC facilities had no signage to indicate they are accessible WCs</p>	<p>The appropriate toilet signage should be provided as part of the recommended way finding review, refer to 15.1. As well as signage on the toilet doors, there should also be signs indicating where the accessible WC is located.</p> <p>BS8300 states - Information and direction signs should be provided at each point where they are required, e.g. at junctions of circulation routes, at key locations such as doorways and reception points, at facilities such as telephones and toilets, and in rooms, spaces and counters. The colour, design and typeface of signs should be consistent throughout a building.</p>

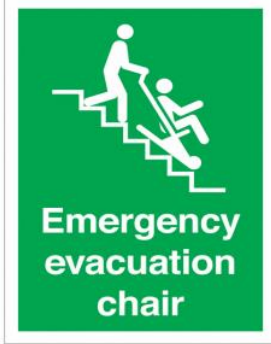
<p>17.5</p>	<p>No evacuation chair was seen or indicated as being available</p>

<p>In order to evacuate disabled people from upper floors or areas where stepped exits are required, suitable equipment should be available within fire refuges. This equipment is often an evacuation chair that requires disabled people to transfer to the evacuation chair before safely descending a protected stairway to a final exit. It is important that the quality of the equipment is high and that there is enough equipment to cater for the expected use of the building by disabled people. https://directaccessgp.com/evacuation-solutions/</p> <p>Signage should be provided to indicate the location of the Evacuation chairs. Depending on where a fire risk assessment identifies the need for a sign, the sign should be displayed prominently, conspicuously and appropriately having regard to the environment and occupancy characteristic of the building.</p>	<p>M</p>	<p>Completed Feb 24</p>

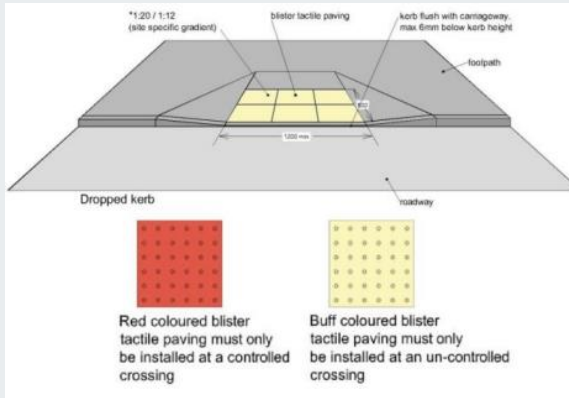
1.2 There is no tactile paving provided to the crossing points on approach to the site to aid people with impaired vision. The crossings within the school site also have no tactile paving.

Depending on the responsible authority (i.e. Bradford Council), contact the Highways Department responsible for the routes on approach to the site (or school site management for internal areas), and request to provide tactile paving in areas where there are dropped kerbs to aid people with impaired vision. ADM states that an uncontrolled crossing point across the vehicular route should be identified by a buff-coloured blister surface.

Any tactile paving a must be installed correctly and in accordance with Guidance on the use of Tactile Paving Surfaces 2021, See: https://assets.publishing.service.gov.uk/government/uploads/system/uploads/attachment_data/file/1046126/guidance-on-the-use-of-tactile-paving-surfaces.pdf

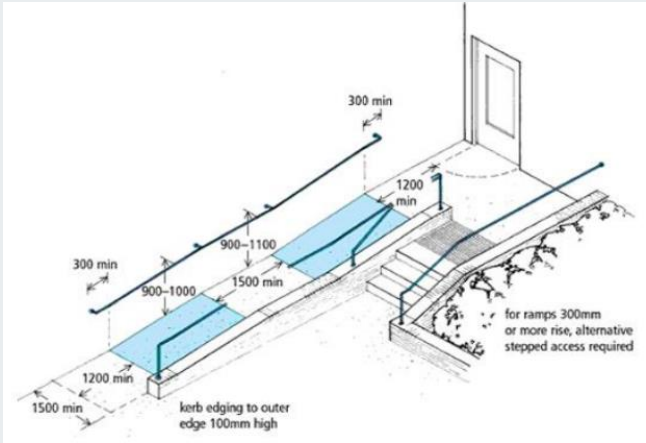
3.2	<p>Ramps from the entrance gates do not have suitable handrails.</p>

<p>Handrails are a relatively simple and cost-effective adjustment that provides a range of benefits; support, guidance, guarding and route definition. All of these features improve accessibility for disabled people. Implement a rolling programme to upgrade handrails to achieve AD M and BS8300 compliance. Ramps serving communal facilities and access routes used by disabled people should be prioritised with others included as part of any refurbishment or alteration works in future.</p> <p>ADM vol-2 requires handrails on both sides. BS8300 compliant handrails should be installed to both sides of a ramp. The handrails should be coated with nylon or a suitable alternative to ensure that they are not cold to touch. The handrails should provide the required 300mm horizontal landing extensions with the entire handrail located at a height of 900-1000mm from the slope and landing surface as required by BS8300 and ADM vol-2.</p>	M/OG

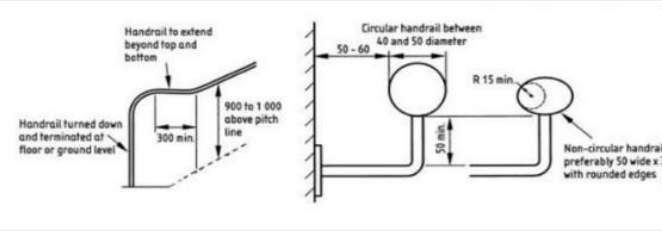
4.2	<p>Some external steps do not have handrails on either side, and some only have one handrail.</p> <p>All handrails seen have good contrasting.</p>

<p>BS8300 compliant handrails should be installed. The handrails should be replaced with a BS8300 oval style profile and be coated with nylon or a suitable alternative to ensure that they are not cold to touch.</p> <p>The handrails should have a suitable profile (circular: 40 – 45mm, oval 50mm, in diameter) that projects at least 60 - 75mm clear of the adjacent wall – 50mm between a cranked support and the underside of the handrail.</p> <p>The handrail needs to extend at least 300mm beyond the top and the bottom of the steps and should not project into the route of travel.</p> <p>Handrails should contrast with the surroundings against which they are seen.</p>	M

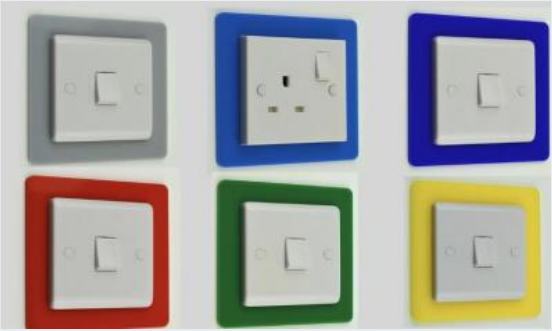
<p>For reach heights of information, it is recommended that items on display should be positioned such that they can be reached independently. Comfortable reach range for a wheelchair user would be at a height of 1000-650mm (750mm at the horizontal reference plane) and a depth of 180 - 90mm (180mm at the horizontal reference plane).</p>		
<p>16.2</p>	<p>The majority of the light switch plates are not suitably colour contrasted against their background.</p> <p>Some were also located too high.</p> <p>Samples of switch heights, from floor level: 1288mm 1350mm gym hall</p>

<p>At the next refurbishment for the sites, it would be beneficial to change the existing light switch plates with alternatives that have a grey/silver plate.</p> <p>Alternatively, light switch plates with a contrasting surround could be used.</p> <p>This will ensure that they are easily located by people with impaired vision.</p>	<p>M</p>

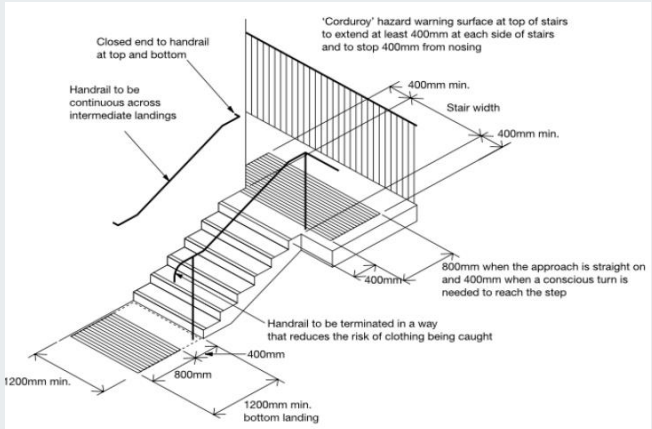
<p>4.1</p>	<p>External steps do not feature tactile paving to assist people with impaired vision.</p> <p>Playground Treads</p> <p>906mm Risers 228mm No handrails</p> <p>By Elm Treads 315mm Risers 151mm</p> <p>By Sports hall</p> <p>Treads 309mm Risers 155mm</p> <p>Treads 302mm Risers 170mm</p> <p>Treads 325mm Risers 193mm</p> <p>Rear of Sports Hall</p>	<p>Tactile paving is an important hazard indicator for blind and partially sighted people and is expected to be present. Implement a rolling programme to install tactile hazard warning paving to the top and bottom of steps where two or more steps are present. Steps serving communal facilities and access routes used by disabled people should be prioritised with others included as part of any refurbishment or alteration works in future. ADM vol-2 requires a corduroy hazard warning surface provided at the top and bottom of each flight of 800mm x 1200mm minimum, 400mm from the step.</p> <p>BS8300 - To give advance warning of a step, tactile paving with a corduroy hazard warning surface should be provided at the top and bottom of each flight, excluding intermediate landings with continuous handrails. Where the approach to the stair is</p>	<p>M/ST</p>

<p>Treads 311mm Risers 180mm</p> <p>To carpark</p> <p>Treads 695mm Risers 192mm, 182mm</p> <p>External offices</p> <p>Treads 312mm Risers 150mm Handrails one side</p>	<p>wider than the flight, the tactile surface should extend beyond the line of each edge</p>
