Nessfield Accessibility Action Plan

4.1 Action Table				
COSTS – N = NONE M= MINIMAL OG = ONGOING MAINTENANCE ST = STRUCTURAL CHANGE EX = MAJOR STRUCTUARL CHANGE				
Item Ref.	Details/Issue	Recommendation	Est Cost	Action Taken
PRIORITY A

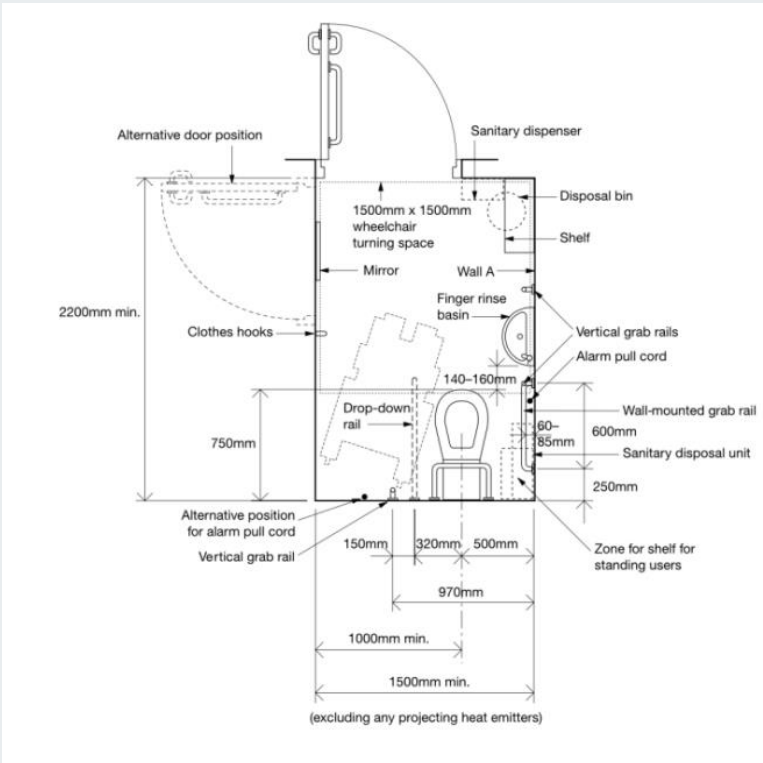
<p>6.5</p>	<p>Two accessible WC facilities are provided but both are obstructed with furnishings or bins restricting their use.</p> <p>Accessible WC with shower and hoist Room 39 Used as first aid room. Kept locked - key locker, located high.</p> <p>Hoist is blocked.</p> <p>Ramp is provided for shower.</p> <p>Door opens inwards and no grab rail.</p> <p>Accessible WC 66 peninsular style</p> <p>Compartment 2147x2506mm</p> <p>Door 843mm open width</p> <p>Grab rail 1049mm</p>	<p>Implement a management procedure to ensure that any furnishing or items stored and provided to the accessible WCs do not reduce the available size of the compartment to beneath ADM requirements, as shown in the diagram:</p>

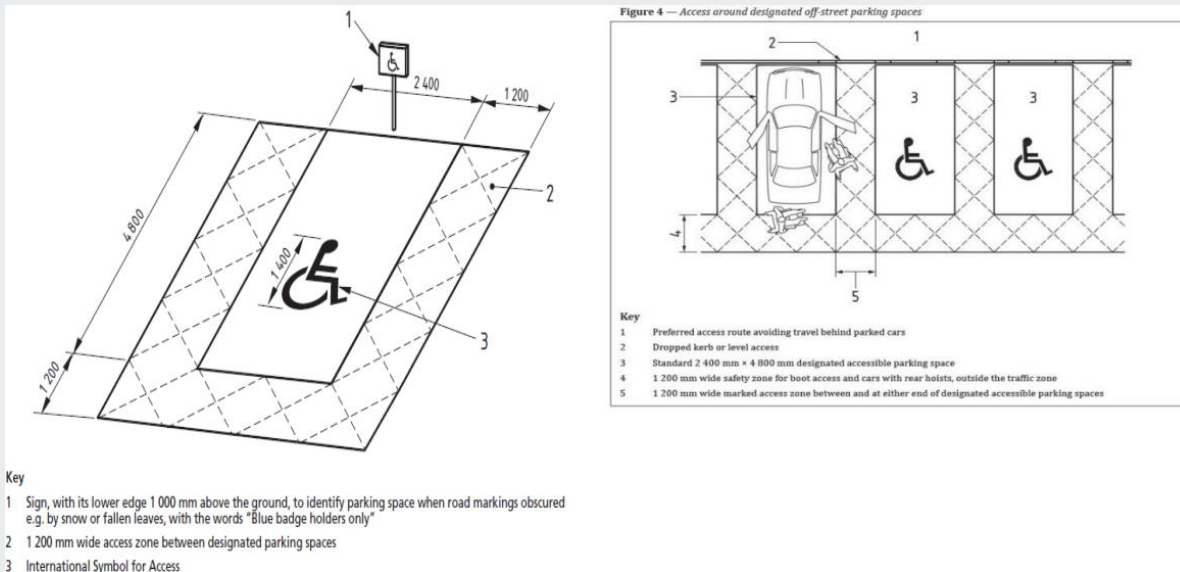
2.3
Cont

2.3	The designated accessible parking should be clearly marked out at least 2.4m wide x 4.8m long plus a 1.2m side transfer zone at the side and end of the bay.	<p>The accessible bay markings should provide clearly defined 1200mm transfer zones to both sides and rear and with the required access symbol.</p> <p>BS8300 recommends a sign or, if appropriate, signs should be provided at the entrance to each car park and at each change in direction to direct disabled motorists to designated parking spaces. Also, install a sign to the front of each space as shown:</p>	M

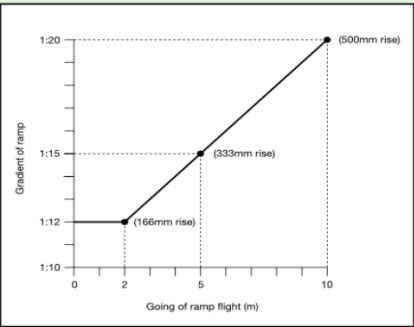
<p>Diagram 3 Relationship of ramp gradient to the going of a flight</p>

3.1	<p>The ramps do not have colour contrast to the surface to indicate the presence of a gradient. Some ramps are steep such as those from the entrance gates (3, 4) which have a gradient of over 1:12. They also do not have handrails on both sides, or for the full incline.</p> <p>Playground has slopes which appear to be within gentle slope range. Playground slopes Ramp by Elm Width 1044mm Gradient 4/5deg Ramp to upper carpark after steps Width 1190mm Gradient 4deg External offices Gradient 8deg Longer ramp Gradient 5deg Part handrails both sides Ramp from gate 4 Width 1242mm Gradient max 5deg Ramp from gate 3 Gradient max 10de</p>	<p>ADM require ramp gradients to be within 1:20 - 1:12. Dependent on heritage requirements, surfaces need to be slip-resistant especially when wet and of a colour that contrasts visually with that of the landings.</p> <p>Some of the current access route ramps are of a gradient steeper than that deemed reasonable under ADM. Where possible, during any future works, the gradients of these primary access routes should be reduced to provide an ADM compliant ramp gradient as below:</p>	M/ST

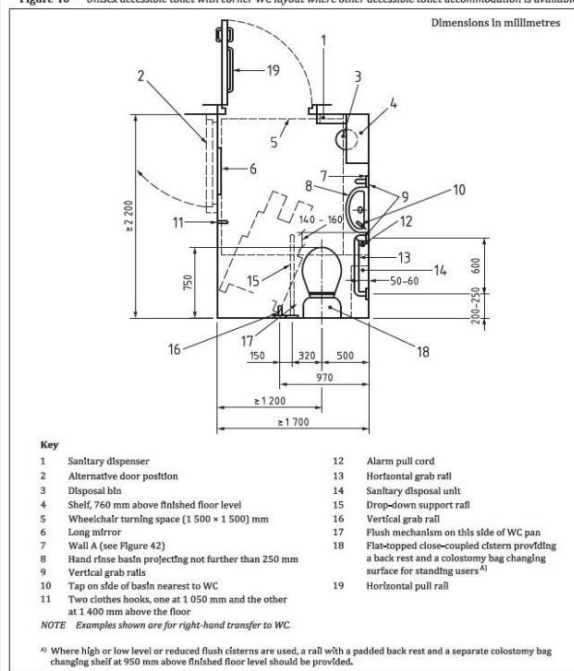
Figure 40 — Unisex accessible toilet with corner WC layout where other accessible toilet accommodation is available

<p>13.2</p>	<p>Accessible WCs are only provided in two parts of the school at almost opposite ends (Block 1 and Block 3). No other accessible facility is provided.</p> <p>The Accessible WC by the main entrance would not meet current BS8300 recommendations.</p>	<p>Proportionate to demand, an architectural feasibility study should be undertaken to provide a further BS8300 compliant accessible WC facility within the lower area of the school, or refurbish the WC by the main entrance. Wheelchair Accessible WC facilities will satisfy ADM requirements if one is located as close as possible to the entrance and/or waiting area of the building.</p> <p>BS8300: A disabled employee or student should not have to travel more than 40 m on the same floor from their workstation to an accessible toilet, or more than 40 m combined horizontal travel distance where accessible toilet accommodation is accessed by conventional passenger lift on another floor of the building.</p> <p>BS8300 should be referred to for the suggested layout and guidance, with the minimum recommended layout shown below. The door should open outward, an alarm should be installed within the facility and the fittings and grab rails should be well contrasted.</p>	<p>M/ST</p>

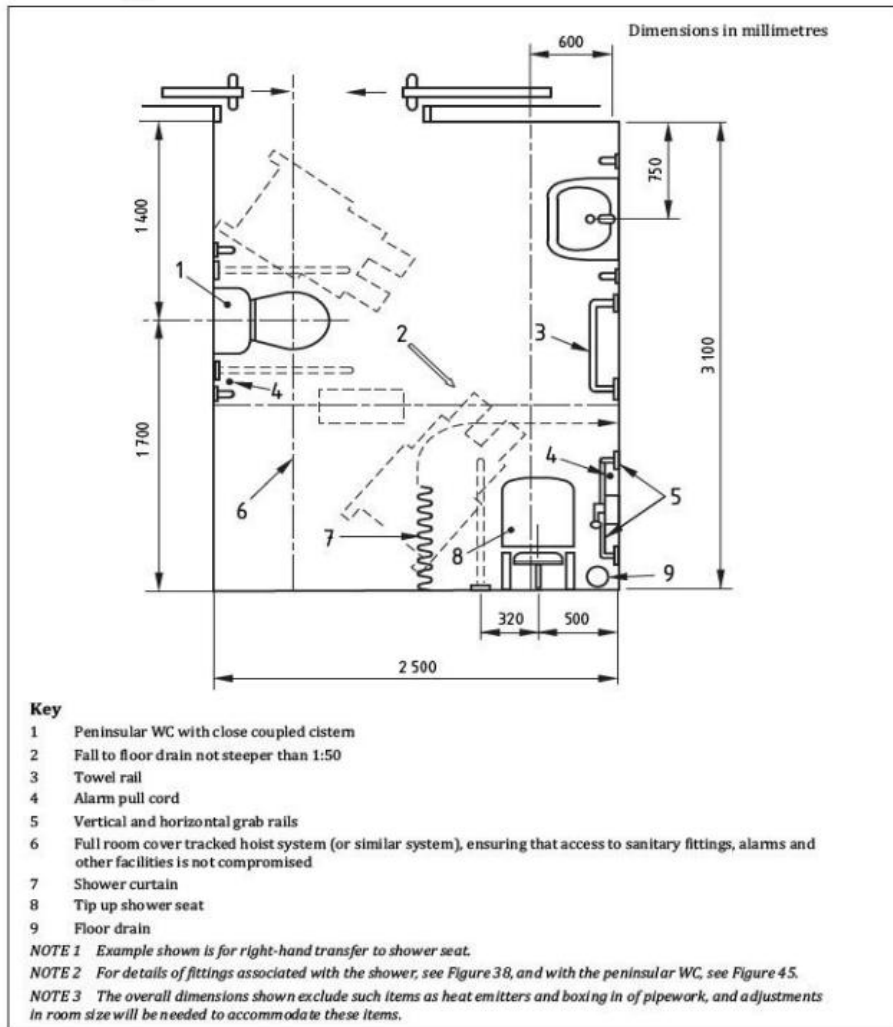
Figure 31 — En-suite shower room for use with a ceiling-mounted full room cover tracked hoist system for assisted use

The Accessible WC with shower and hoist in room 39 has an inward opening door. It is used as first aid room. Kept locked - key locker, located high.

<p>If an inward opening door is the only solution for a cubicle that is accessible to a wheelchair user, a clear minimum space (on plan) of 800 mm x 1 400 mm should be provided between the door swing and any fittings (including drop-down rails when in the down position) to enable a wheelchair user to enter and close the door behind them.</p>		
<p>13.4</p>	<p>The Accessible WC with shower and hoist in room 39 has an inward opening door. It is used as first aid room. Kept locked - key locker, located high.</p> <p>It has no grab rail. The light switch is also obstructed by a filing cabinet.</p>	<p>Outward opening accessible WC doors should have a well contrasted horizontal pull/ grab-rail fitted to the interior face where no door closing device is fitted. This should be at a height of 800-1050mm with 900mm being preferred.</p>	<p>M</p>	
<p>13.7</p>	<p>Accessible WC 66 is peninsular style and is missing the right-side grab rail by the sink.</p> <p>The Accessible WC with shower and hoist in Room 39 is not laid out following any particular recommendations and is missing grab rails by the sink. The WC is also not positioned as for a usual peninsular style WC with limited space to either side of the WC pan.</p>	<p>A full BS8300 compliant set of grab rails should be provided where required, appropriate to the layout of the WC provided. Refer to the images below for locations of the required grab rails. The WC by the reception may need to be refurbished to meet BS8300 recommendations and to provide sufficient space to transfer to the WC pan.</p> <p>Ensure any installed fixtures and fittings contrast from the surrounding surfaces.</p>	<p>M/ST</p>

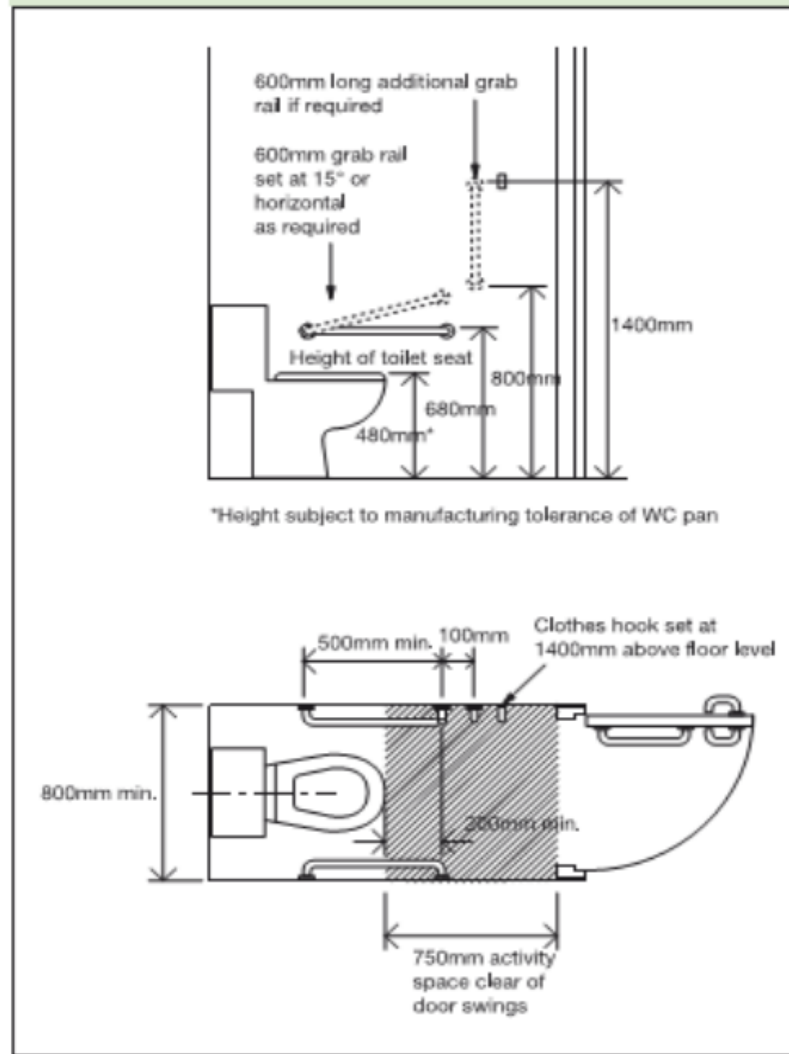
Diagram 21 **WC cubicle for ambulant disabled people**

12.1	<p>Some staff WCs had limited room to manoeuvre when entering them.</p> <p>Staff WC 37</p> <p>Lock located high.</p> <p>Children's WCs 19, 20 same colour cubicles</p> <p>Boys WC 6, Girls WC 8</p> <p>Staff WC 137</p> <p>Children's WC 59, 55</p> <p>Staff WC area 61</p> <p>Children's WCs 68, 69 lever taps.</p>	<p>While an accessible WC is provided there are no facilities for ambulant disabled persons. It would be recommended to provide general WCs with space within it to be manoeuvrable, or used as an WC for ambulant disabled people. The door can be changed to an outward opening door, a slide door or a pivot door to increase internal manoeuvring space.</p> <p>ADM recommends the following for a cubicle, and refer to BS8300 for layout of a unisex toilet - also see recommendation 12.7.</p> <p>The swing of any inward opening doors to standard WC compartments should allow a 450mm diameter manoeuvring space between the swing of the door, the WC pan and the side wall of the compartment;</p> <p>The minimum dimensions of compartments for ambulant disabled people, including the activity space, and the arrangement of grab bars and other fittings within the compartment are as follows.</p>	M/ST

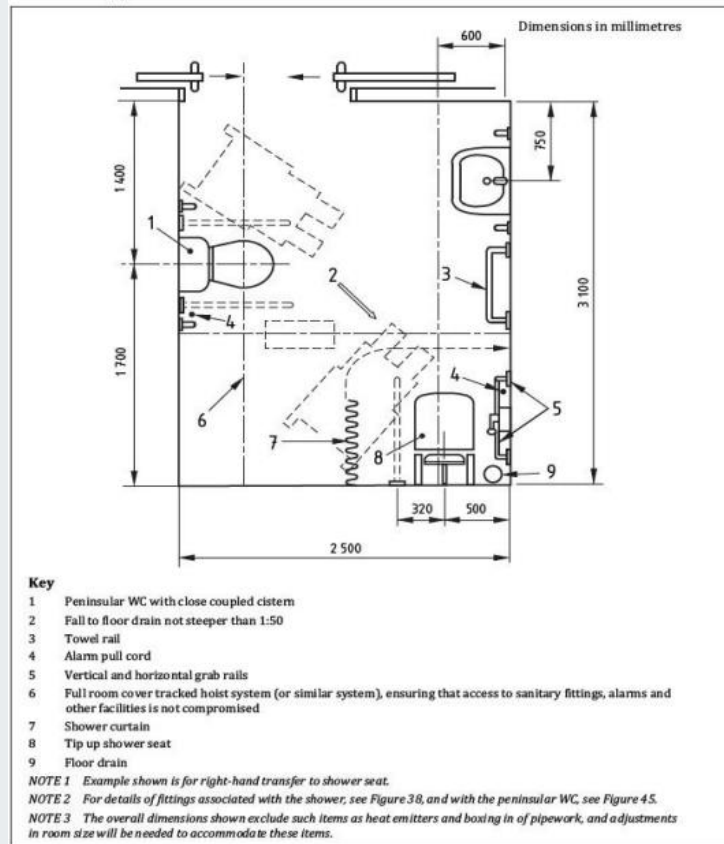
Figure 31 — En-suite shower room for use with a ceiling-mounted full room cover tracked hoist system for assisted use

An accessible shower is provided if this is not in regular use. This does not have grab rails but a seat is provided.
